Exhibit 2: Site Photos

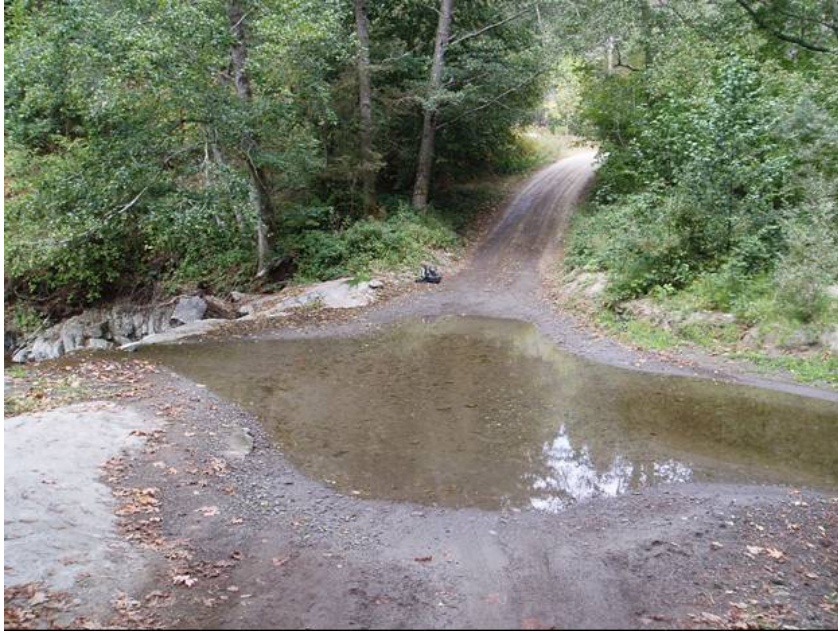
Above: Tucker Road Ford – stream is flowing across the wet crossing right to left. Sediment accumulating upstream of the ford has raised the elevation of the streambed.
